RESERVE ANALYSIS REPORT

Laurelmont Community Association

Aliso Viejo, California Version 1 April 30, 2021

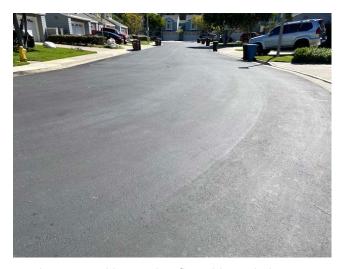
According to the previous reserve study, prepared by another firm, this asphalt was removed and replaced during 2010.

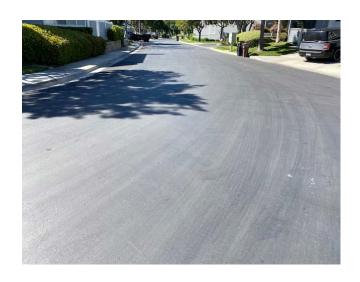
94,398	sq. ft. of overlay	@	\$2.00	=	\$188,796.00
41	valve cover adjustments	@	\$200.00	=	\$8,200.00
20	manhole cover adjustments	@	\$600.00	=	\$12,000.00
			TOTAL	=	\$208,996.00

According to the previous reserve study, prepared by another firm, this asphalt was removed and replaced at the end of 2012 for a total cost of \$145,000.

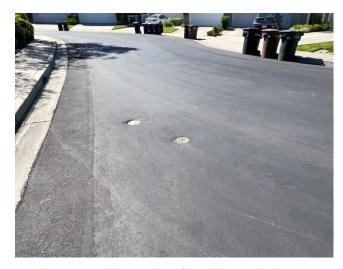
According to the previous reserve study, prepared by another firm, this asphalt was removed and replaced during 2011.

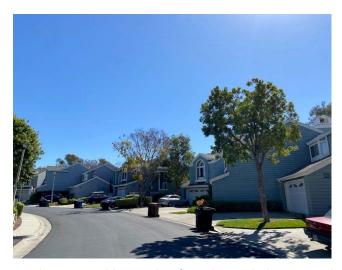
According to the previous reserve study, prepared by another firm, the asphalt was repaired and seal coated during 2010 and repaired again during 2018. The actual date this component was placed into service is not available. For budgeting purposes, this date has been estimated based on its condition at our most recent site visit.

It is estimated that a percentage of the asphalt areas will require repair or replacement. The actual condition of the asphalt should be monitored through time and these estimates adjusted accordingly.

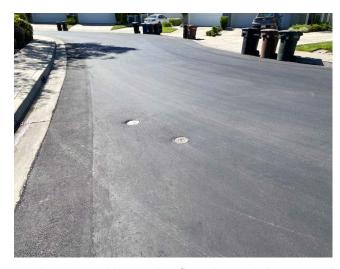
According to the previous reserve study, prepared by another firm, the asphalt was repaired and seal coated during 2011 and repaired again during 2018. The actual date this component was placed into service is not available. For budgeting purposes, this date has been estimated based on its condition at our most recent site visit.

It is estimated that a percentage of the asphalt areas will require repair or replacement. The actual condition of the asphalt should be monitored through time and these estimates adjusted accordingly.

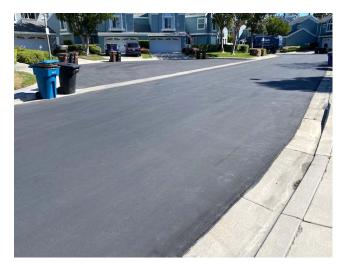
According to the previous reserve study, prepared by another firm, the asphalt seal coated at the end of 2012 for a total cost of \$4,780 and again during 2018.

Asphalt surfaces should be seal coated on a 3 to 4 year cycle.

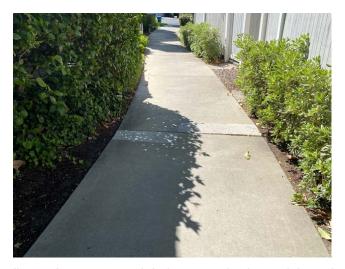
There are typical concrete sidewalks, curbs, gutters and drainage swales located throughout the community.

According to the previous reserve study, prepared by another firm, the concrete was repaired during 2013.

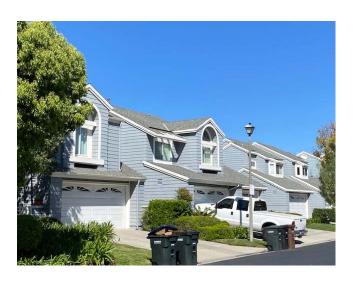
Roofing - Composition Shingle			
Category	020 Roofing	Quantity	411,958 sq. ft.
Photo Date	April 2020	Unit Cost	\$6.500
		% of Replacement	100.00%
		Current Cost	\$2,677,727.00
Placed In Service	01/99	Future Cost	\$2,813,286.93
Useful Life	20		
Adjustment	+5	Assigned Reserves at FYB	\$2,463,508.84
Remaining Life	2	Monthly Member Contribution	\$11,432.46
Replacement Year	2024	Monthly Interest Contribution	\$2,216.55
		Total Monthly Contribution	\$13,649.00

units 411,766 sq. ft. cabana 192 411,958 sq. ft.

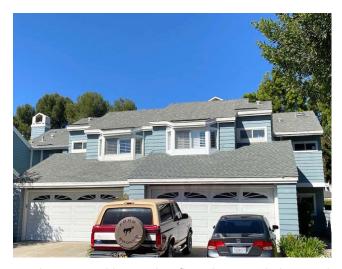
According to the previous reserve study, prepared by another firm, the association repaired the roofs during 2015 for a total cost of \$19,800.

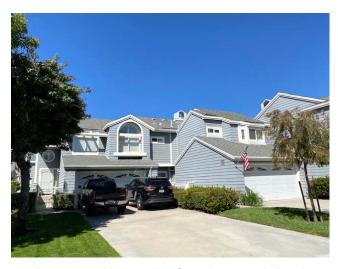
According to the previous reserve study, prepared by another firm, the association the remaining flat roofs during 2005.

According to the previous reserve study, prepared by another firm, the association repaired the roofs during 2015 for a total cost of \$19,800.

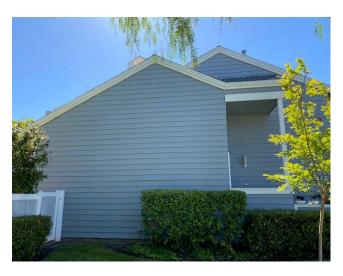
units	424,890	sq. ft.
pool area	1,802	
cabana	720	
	427 412	sa ft

According to the previous reserve study, prepared by another firm, the community was painted in February 2007 for a total cost of \$420,595. According to the previous reserve study, prepared by another firm, the community was painted in September 2015 for a total cost of \$223,425. The association received 4 quotes averaging a total cost of \$241,012; the association intends to complete this work before the end of 2021.

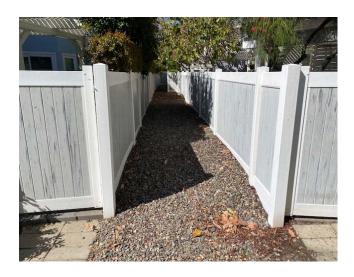
12,399 lin. ft. of vinyl fencing 197 vinyl gates

According to the previous reserve study, prepared by another firm, this vinyl fencing was replaced during 2003 for 179 units for a total cost of \$435,233.

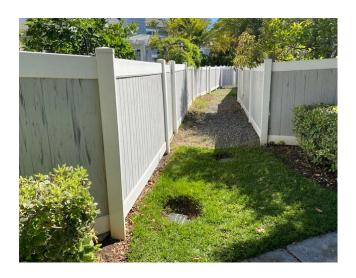
12,399 lin. ft. of vinyl fencing 197 vinyl gates

According to the previous reserve study, prepared by another firm, this rest of the vinyl fencing was replaced at the end of 2010 for 18 units for a total cost of \$34,148.

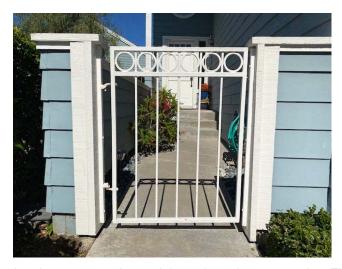
These 2.5" x 3.5' wrought iron pedestrian gates are located throughout the community. The association repaired the wrought iron gates and pool fencing in 2020 for a total cost of \$16,934.

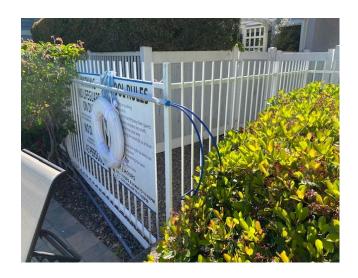
Fencing - Wroug	ht Iron, Pool		
Category	040 Fencing, Gates & Walls	Quantity	1 total
Photo Date	April 2020	Unit Cost	\$22,605.000
		% of Replacement	100.00%
		Current Cost	\$22,605.00
Placed In Service	03/86	Future Cost	\$32,738.78
Useful Life	25		
Adjustment	+26	Assigned Reserves at FYB	\$0.00
Remaining Life	15	Monthly Member Contribution	\$133.19
Replacement Year	2037	Monthly Interest Contribution	\$0.68
		Total Monthly Contribution	\$133.87

This wrought iron is located at the pool area:

191	- lin. ft. of 5' fencing	@	\$55.00	=	\$10,505.00
84	- lin. ft. of 7' fencing	@	\$75.00	=	\$6,300.00
1	- 2' x 6' wood gate, pump room	@	\$600.00	=	\$600.00
4	- 4' x 7' ped gates	@	\$1,050.00	=	\$4,200.00
1	- 3' x 7' gate w/shepard hook	@	\$1,000.00	=	\$1,000.00
			TOTAL	=	\$22,605.00

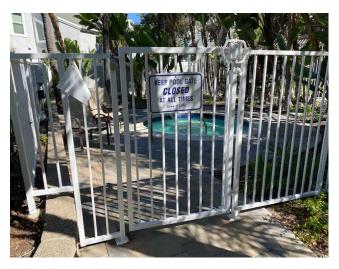
This 3' x 5' pedestrian gate is located at the spa area.

According to the previous reserve study, prepared by another firm, the spa gate was replaced in April 2011.

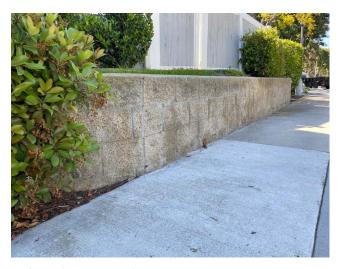
These block walls are located throughout the community:

ground	2,419	sq. ft.
pool area	544	
	2.963	sa. ft.

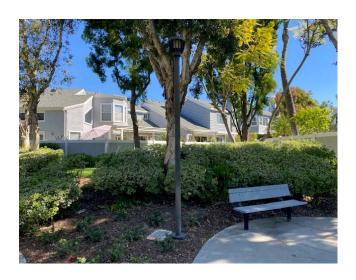
Lighting - Groun	ds		
Category	050 Lighting	Quantity	1 total
Photo Date	April 2020	Unit Cost	\$11,800.000
		% of Replacement	100.00%
		Current Cost	\$11,800.00
Placed In Service	03/86	Future Cost	\$13,350.62
Useful Life	25		
Adjustment	+16	Assigned Reserves at FYB	\$10,355.10
Remaining Life	5	Monthly Member Contribution	\$35.53
Replacement Year	2027	Monthly Interest Contribution	\$9.26
		Total Monthly Contribution	\$44.79

These light fixtures are located throughout the community:

9	pagodas	@	\$400.00	=	\$3,600.00
3	bollards	@	\$1,500.00	=	\$4,500.00
2	meta poles w/vapors	@	\$1,850.00	=	\$3,700.00
			TOTAL	=	\$11,800.00

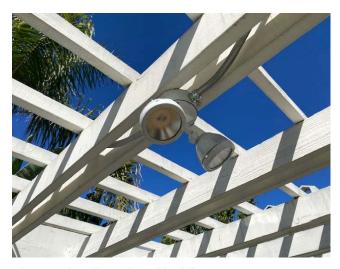
Lighting - Pool A	rea, 2016		
Category	050 Lighting	Quantity	1 provision
Photo Date	April 2020	Unit Cost	\$3,500.000
		% of Replacement	100.00%
		Current Cost	\$3,500.00
Placed In Service	01/16	Future Cost	\$4,945.41
Useful Life	20		
		Assigned Reserves at FYB	\$0.00
Remaining Life	14	Monthly Member Contribution	\$21.94
Replacement Year	2036	Monthly Interest Contribution	\$0.11
		Total Monthly Contribution	\$22.05

These light fixtures are located on the wood trellis and pool building:

- 3 small LED fixtures
- 2 small dbl-flood lights
- 2 small sgl-flood lights
- 1 small round fixture

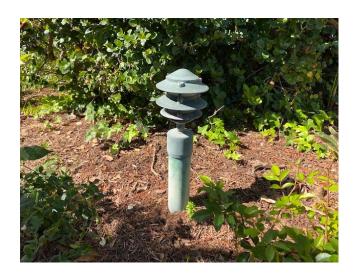
Lighting - Pool A	rea, Original		
Category	050 Lighting	Quantity	1 total
Photo Date	April 2020	Unit Cost	\$5,060.000
		% of Replacement	100.00%
		Current Cost	\$5,060.00
Placed In Service	03/86	Future Cost	\$5,724.93
Useful Life	20		
Adjustment	+21	Assigned Reserves at FYB	\$4,440.41
Remaining Life	5	Monthly Member Contribution	\$15.24
Replacement Year	2027	Monthly Interest Contribution	\$3.97
		Total Monthly Contribution	\$19.20

These light fixtures are located at the pool area:

12	pagodas	@	\$400.00	=	\$4,800.00
2	ceiling fixtures	@	\$130.00	=	\$260.00
			TOTAL	=	\$5,060,00

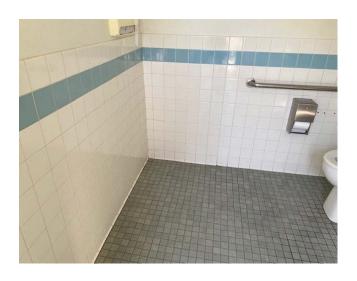
251 sq. ft. of wall tile	@	\$27.50	=	\$6,902.50
121 sq. ft. of floor tile	@	\$25.00	=	\$3,025.00
		TOTAL	=	\$9 927 50

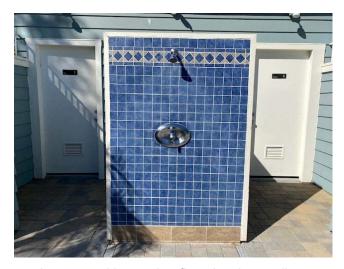
Cabana - Cerami	c Tile, Shower		
Category	060 Pool Area	Quantity	1 total
Photo Date	April 2020	Unit Cost	\$2,280.000
		% of Replacement	100.00%
		Current Cost	\$2,280.00
Placed In Service	01/14	Future Cost	\$3,925.18
Useful Life	30		
		Assigned Reserves at FYB	\$0.00
Remaining Life	22	Monthly Member Contribution	\$9.61
Replacement Year	2044	Monthly Interest Contribution	\$0.05
		Total Monthly Contribution	\$9.66

According to the previous reserve study, prepared by another firm, the shower tile was replaced at the end of 2013 for a total cost of \$1,950.

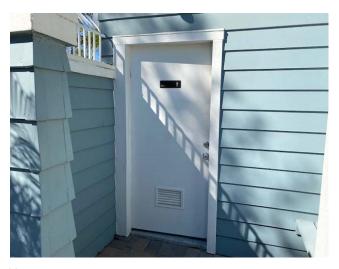
Cabana - Doors			
Category	060 Pool Area	Quantity	2 doors
Photo Date	April 2020	Unit Cost	\$895.000
		% of Replacement	100.00%
		Current Cost	\$1,790.00
Placed In Service	01/07	Future Cost	\$2,025.22
Useful Life	20		
		Assigned Reserves at FYB	\$1,342.50
Remaining Life	5	Monthly Member Contribution	\$8.90
Replacement Year	2027	Monthly Interest Contribution	\$1.23
		Total Monthly Contribution	\$10.12

These are 3' x 6'8" metal doors with vents.

According to the previous reserve study, prepared by another firm, these doors were replaced in July 2006 for a total cost of \$1,237.

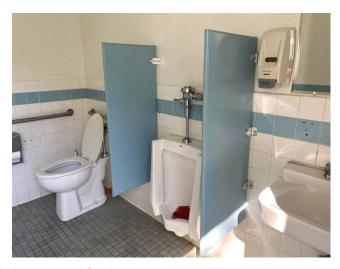
Cabana - Partitio	ns		
Category	060 Pool Area	Quantity	2 partitions
Photo Date	April 2020	Unit Cost	\$735.000
		% of Replacement	100.00%
		Current Cost	\$1,470.00
Placed In Service	03/86	Future Cost	\$1,583.03
Useful Life	20		
Adjustment	+19	Assigned Reserves at FYB	\$1,356.44
Remaining Life	3	Monthly Member Contribution	\$4.61
Replacement Year	2025	Monthly Interest Contribution	\$1.22
		Total Monthly Contribution	\$5.83

These are metal partitions with baked enamel finish.

The remaining life of this component has been extended due to the recommendation of a previous reserve study, prepared by another firm.

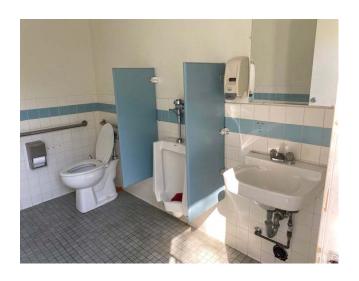
2	toilets, flush valve	@	\$1,150.00	=	\$2,300.00
2	sinks, wall mount	@	\$750.00	=	\$1,500.00
1	urinal	@	\$750.00	=	\$750.00
1	drinking fountain, chilled	@	\$1,250.00	=	\$1,250.00
			TOTAL	=	\$5,800.00

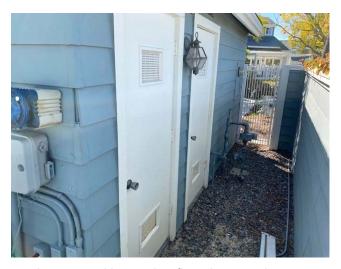
Cabana - Water Heater			
Category	060 Pool Area	Quantity	1 heater
Photo Date	April 2020	Unit Cost	\$1,375.000
		% of Replacement	100.00%
		Current Cost	\$1,375.00
Placed In Service	01/99	Future Cost	\$1,409.38
Useful Life	10		
Adjustment	+14	Assigned Reserves at FYB	\$1,317.71
Remaining Life	1	Monthly Member Contribution	\$6.08
Replacement Year	2023	Monthly Interest Contribution	\$1.19
		Total Monthly Contribution	\$7.27

According to the previous reserve study, prepared by another firm, the water heater was replaced during 1999.

The remaining life of this component has been extended due to no issues reported.

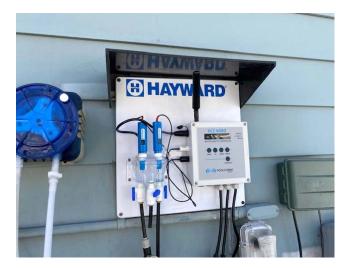
According to the previous reserve study, prepared by another firm, this chemical controller was replaced during 2010. The association replaced the chemical controller during 2020 for a total cost of \$2,583.

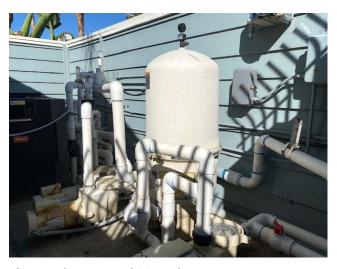
These "Pentair" pool filters have a filter surface area of 60 sq. ft.

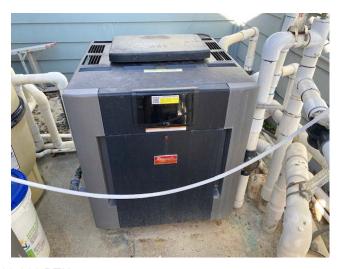
This is a "Raypak" heater with 399,000 BTUs.

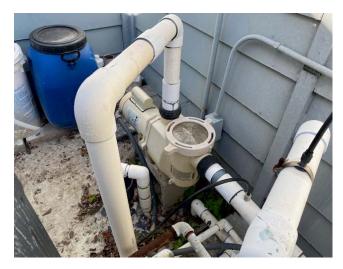
These are 3hp motors with pumps.

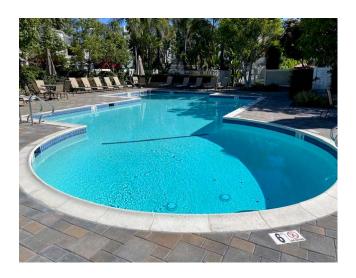
1,224 sq. ft. of replastering 168 lin. ft. of trim tile 140 lin. ft. of step tile

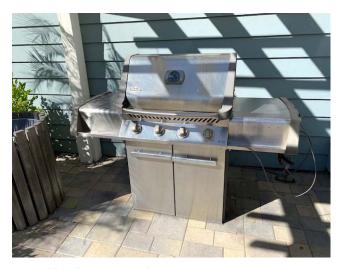
Pool Area - BBQs			
Category	060 Pool Area	Quantity	2 BBQs
Photo Date	April 2020	Unit Cost	\$1,455.000
		% of Replacement	100.00%
		Current Cost	\$2,910.00
Placed In Service	05/13	Future Cost	\$2,982.75
Useful Life	10		
		Assigned Reserves at FYB	\$2,608.97
Remaining Life	1	Monthly Member Contribution	\$27.08
Replacement Year	2023	Monthly Interest Contribution	\$2.42
		Total Monthly Contribution	\$29.50

These are "Napoleon" gas barbecues with 4 burners each.

According to the previous reserve study, prepared by another firm, these barbecues were replaced in May 2013 for a total cost of \$2,448.

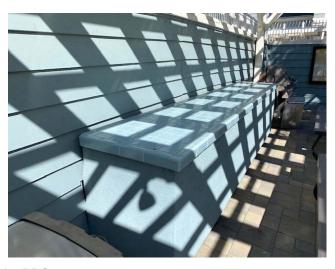
Pool Area - Ceramic Tile Counter			
Category	060 Pool Area	Quantity	12 lin. ft.
Photo Date	April 2020	Unit Cost	\$130.000
		% of Replacement	100.00%
		Current Cost	\$1,560.00
Placed In Service	03/86	Future Cost	\$1,765.00
Useful Life	30		
Adjustment	+11	Assigned Reserves at FYB	\$1,368.98
Remaining Life	5	Monthly Member Contribution	\$4.70
Replacement Year	2027	Monthly Interest Contribution	\$1.23
		Total Monthly Contribution	\$5.92

This ceramic tile is located near the BBQ area.

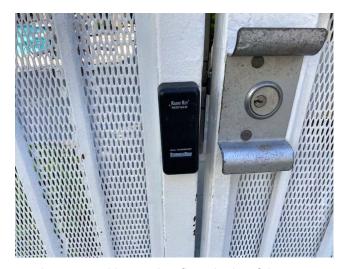
Pool Area - Key Fob System			
Category	060 Pool Area	Quantity	1 total
Photo Date	April 2020	Unit Cost	\$1,215.000
		% of Replacement	100.00%
		Current Cost	\$1,215.00
Placed In Service	04/11	Future Cost	\$1,245.38
Useful Life	8		
Adjustment	+4	Assigned Reserves at FYB	\$1,111.60
Remaining Life	1	Monthly Member Contribution	\$9.55
Replacement Year	2023	Monthly Interest Contribution	\$1.03
		Total Monthly Contribution	\$10.57

According to the previous reserve study, prepared by another firm, the key fob system was replaced in April 2011.

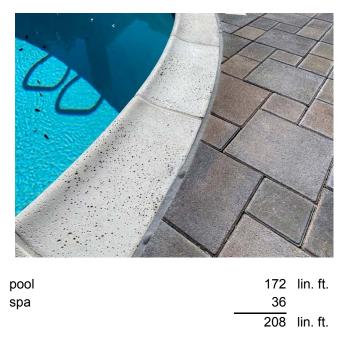
According to the previous reserve study, prepared by another firm, the mastic was replaced at the end of 2013 for a total cost of \$1,100 and again during 2018.

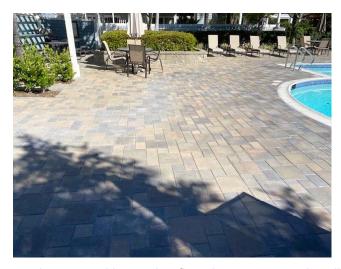
Pool Area - Pool	Deck, Pavers		
Category	060 Pool Area	Quantity	1 total
Photo Date	April 2020	Unit Cost	\$67,853.565
		% of Replacement	25.00%
		Current Cost	\$16,963.39
Placed In Service	01/14	Future Cost	\$22,813.88
Useful Life	20		
		Assigned Reserves at FYB	\$0.00
Remaining Life	12	Monthly Member Contribution	\$122.39
Replacement Year	2034	Monthly Interest Contribution	\$0.63
		Total Monthly Contribution	\$123.02

According to the previous reserve study, prepared by another firm, the pavers were installed at the end of 2013 for a total cost of \$56,848.

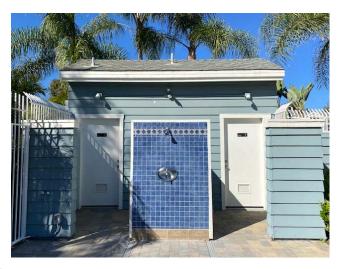
This is to re-plumb the pool equipment room.

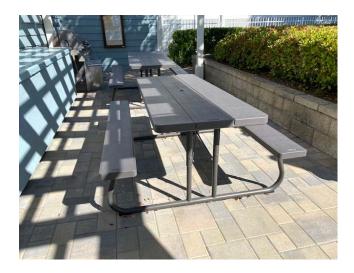
Pool Area - Table	es & Benches		
Category	060 Pool Area	Quantity	1 total
Photo Date	April 2020	Unit Cost	\$6,395.000
		% of Replacement	100.00%
		Current Cost	\$6,395.00
Placed In Service	01/20	Future Cost	\$8,815.58
Useful Life	15		
		Assigned Reserves at FYB	\$0.00
Remaining Life	13	Monthly Member Contribution	\$42.89
Replacement Year	2035	Monthly Interest Contribution	\$0.22
		Total Monthly Contribution	\$43.10

According to the previous reserve study, prepared by another firm, these furnishings were replaced during 2007, the association replaced these furnishings during 2019 for a total cost of \$1,213.

2 - 6' plastic/metal fram picnic tables	@	\$1,435.00	=	\$2,870.00
2 - benches (common area)	@	\$750.00	=	\$1,500.00
3 - wood trash receptacles	@	\$675.00	=	\$2,025.00
		TOTAL	=	\$6,395.00

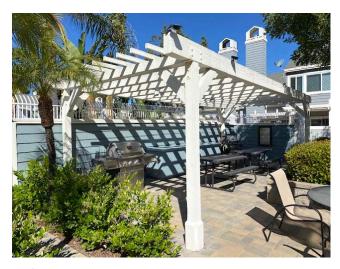
Pool Area - Trellis			
Category	060 Pool Area	Quantity	378 sq. ft.
Photo Date	April 2020	Unit Cost	\$32.500
		% of Replacement	100.00%
		Current Cost	\$12,285.00
Placed In Service	06/15	Future Cost	\$20,130.40
Useful Life	25		
Adjustment	+2	Assigned Reserves at FYB	\$0.00
Remaining Life	20	Monthly Member Contribution	\$56.17
Replacement Year	2042	Monthly Interest Contribution	\$0.29
		Total Monthly Contribution	\$56.46

This wood trellis is located at the pool area.

According to the previous reserve study, prepared by another firm, the trellis was replaced in June 2015.

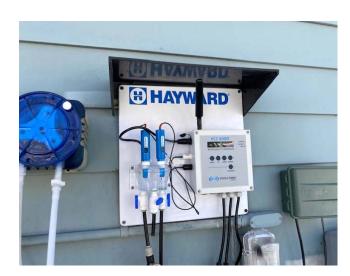
Spa - Chemical Controller			
Category	060 Pool Area	Quantity	1 controller
Photo Date	April 2020	Unit Cost	\$4,612.500
		% of Replacement	100.00%
		Current Cost	\$4,612.50
Placed In Service	01/21	Future Cost	\$5,760.38
Useful Life	10		
		Assigned Reserves at FYB	\$461.25
Remaining Life	9	Monthly Member Contribution	\$39.64
Replacement Year	2031	Monthly Interest Contribution	\$0.61
		Total Monthly Contribution	\$40.24

According to the previous reserve study, prepared by another firm, this chemical controller was replaced during 2010. The association replaced the chemical controller during 2020 for a total cost of \$2,583.

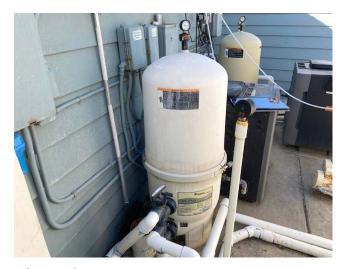
Spa - Filter			
Category	060 Pool Area	Quantity	1 filter
Photo Date	April 2020	Unit Cost	\$1,750.000
		% of Replacement	100.00%
		Current Cost	\$1,750.00
Placed In Service	01/07	Future Cost	\$1,793.75
Useful Life	10		
Adjustment	+6	Assigned Reserves at FYB	\$1,640.63
Remaining Life	1	Monthly Member Contribution	\$10.62
Replacement Year	2023	Monthly Interest Contribution	\$1.49
		Total Monthly Contribution	\$12.12

This filter has a filter surface area of 60 sq. ft.

According to the previous reserve study, prepared by another firm, the filter was replaced during 2007.

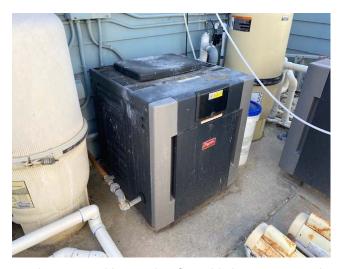
Spa - Heater			
Category	060 Pool Area	Quantity	1 heater
Photo Date	April 2020	Unit Cost	\$3,840.675
		% of Replacement	100.00%
		Current Cost	\$3,840.68
Placed In Service	03/08	Future Cost	\$4,035.11
Useful Life	10		
Adjustment	+6	Assigned Reserves at FYB	\$3,355.54
Remaining Life	2	Monthly Member Contribution	\$23.38
Replacement Year	2024	Monthly Interest Contribution	\$3.06
		Total Monthly Contribution	\$26.44

According to the previous reserve study, prepared by another firm, this heater was replaced in March 2008 for a total cost of \$3,293.

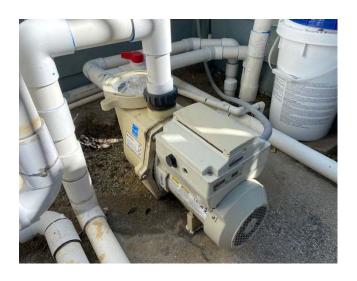
1 - 1.5 HP "Pentair" pump/motor	@	\$1,000.00	=	\$1,000.00
2 - 2 HP "Pentair" booster pumps	@	\$1,250.00	=	\$2,500.00
		TOTAL	=	\$3,500.00

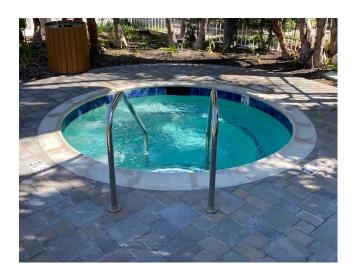
121 sq. ft. of replastering 36 lin. ft. of step tile 32 lin. ft. of trim tile

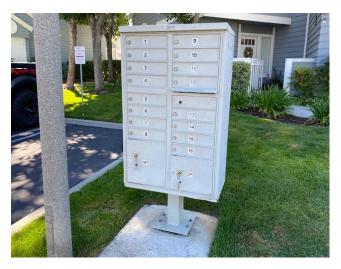
Grounds - Mailbo	oxes		
Category	070 Grounds	Quantity	1 total
Photo Date	April 2020	Unit Cost	\$34,500.000
		% of Replacement	100.00%
		Current Cost	\$34,500.00
Placed In Service	08/09	Future Cost	\$41,009.66
Useful Life	20		
		Assigned Reserves at FYB	\$22,062.23
Remaining Life	7	Monthly Member Contribution	\$173.53
Replacement Year	2029	Monthly Interest Contribution	\$20.22
		Total Monthly Contribution	\$193.74

These are pedestal cluster mailboxes.

According to the previous reserve study, prepared by another firm, the mailboxes were replaced in August 2009 for a total cost of \$26,090.

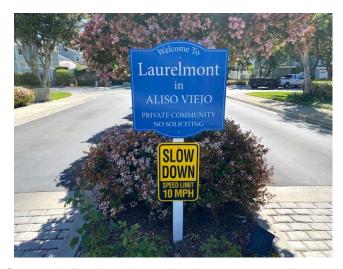
Grounds - Signs	, Monument		
Category	070 Grounds	Quantity	3 signs
Photo Date	April 2020	Unit Cost	\$850.000
		% of Replacement	100.00%
		Current Cost	\$2,550.00
Placed In Service	06/13	Future Cost	\$2,957.22
Useful Life	15		
		Assigned Reserves at FYB	\$1,500.86
Remaining Life	6	Monthly Member Contribution	\$16.22
Replacement Year	2028	Monthly Interest Contribution	\$1.40
		Total Monthly Contribution	\$17.61

These signs read: "Laurelmont Community" and are located at the entrances to the community (3 locations).

According to the previous reserve study, prepared by another firm, these signs were replaced alogn with street signs in June 2013 for a total cost of \$8,133.

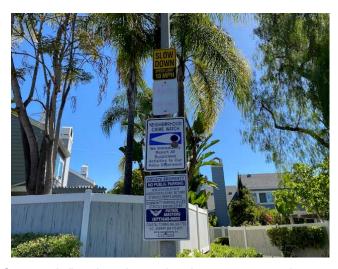
Grounds - Signs, Traffic			
Category	070 Grounds	Quantity	62 signs
Photo Date	April 2020	Unit Cost	\$120.000
		% of Replacement	100.00%
		Current Cost	\$7,440.00
Placed In Service	06/13	Future Cost	\$8,628.12
Useful Life	15		
		Assigned Reserves at FYB	\$4,378.97
Remaining Life	6	Monthly Member Contribution	\$47.32
Replacement Year	2028	Monthly Interest Contribution	\$4.08
		Total Monthly Contribution	\$51.39

These signs read: "Laurelmont Community" and are located at the entrances to the community (3 locations).

According to the previous reserve study, prepared by another firm, these signs were replaced alogn with street signs in June 2013 for a total cost of \$8,133.

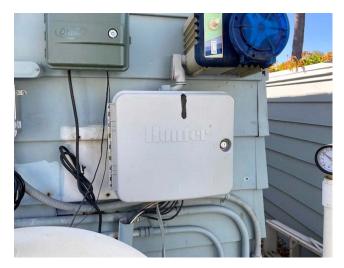
According to the previous reserve study, prepared by another firm, this cabinet was replaced in March 2005.

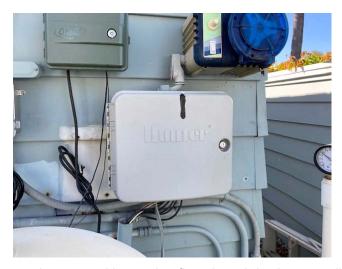
According to the previous reserve study, prepared by another firm, these irrigation controllers were replaced during 2001.

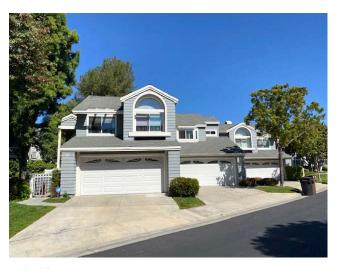
This is for plumbing repairs "as needed."

According to the previous reserve study, prepared by another firm, the community is looking into coating the piping throughout. This will cost approximately \$4,500 per unit. AT this time, the association is not funding for this. However, the association is incorporating this component into the report.

According to the previous reserve study, prepared by another firm, repairs were made to the sewer lines in April 2010.

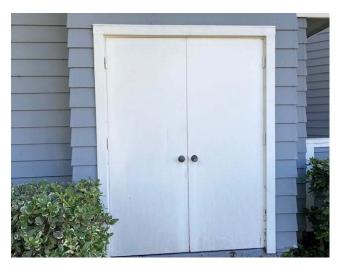
These are 2.5' x 6'8" metal utility doors.

According to the previous reserve study, prepared by another firm, theese doors were replaced during 1992.

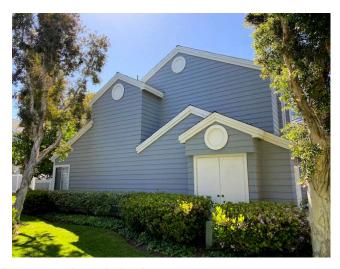
The association spent the following on wood repairs/replacements:

2010: \$10,710 9/2015: \$382,429

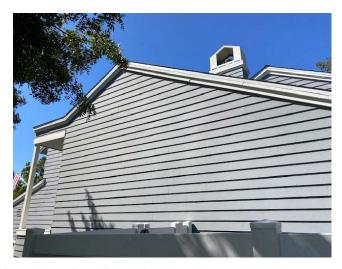
The association spent the following on wood repairs/replacements:

2006: \$30,000
